Manhole Inspection Summary

Manhole # S23CC1023MH

Insp Date: **5/31/07 1:21 PM**

Location Address: **3658 BUENA VISTA AVE**

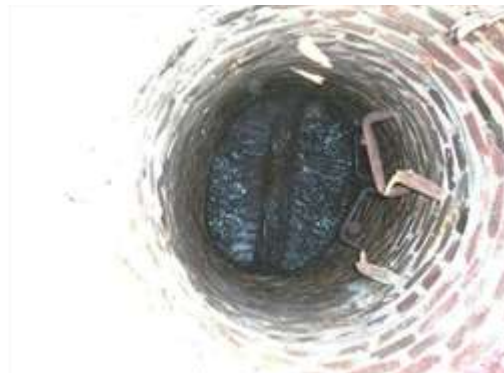
Top View

Corroded and missing steps. Bench debris.

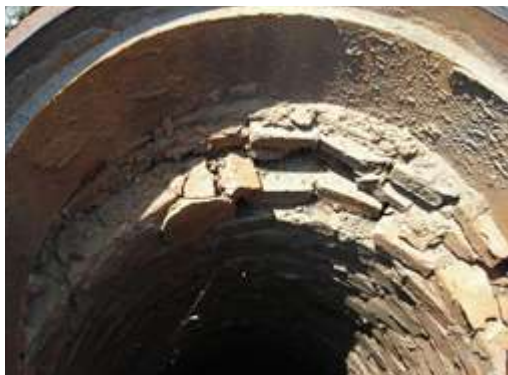
Defect

Frame leaks. Frame offset. Adjustment deterioration, loose brick and infiltration.

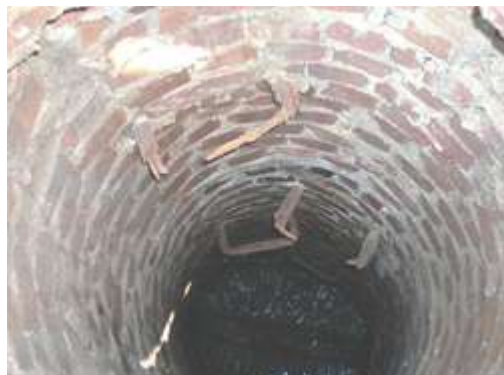
Defect

Adjustment and Barrel infiltration.

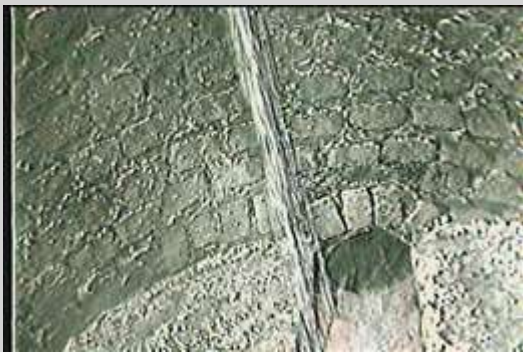
8 in. Circular Gravity Sewer Pipe Out @ 12 O'Clock

Barrel deterioration and infiltration. Bench and Channel deterioration.

Infiltration: **None** Pipe Seal Cond: **Cracked**

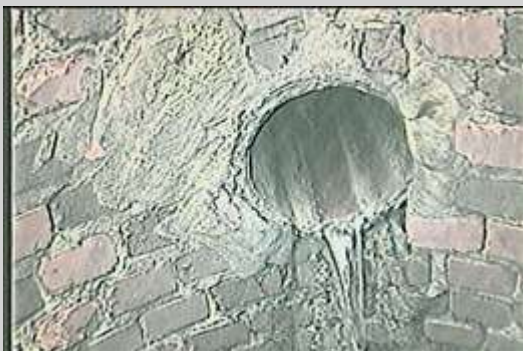
8 in. Circular Gravity Sewer Pipe In @ 6 O'Clock

Infiltration: **None** Pipe Seal Cond: **Cracked**

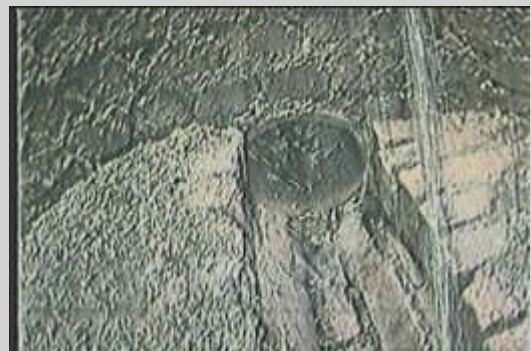
Drop In @ 6 O'Clock

Barrel deterioration and infiltration. Bench and Channel deterioration.

Drop Condition: **Clogged**
